Te Horo Hall

Seismic Strengthening Assessment of Effects on Historic Fabric

16 July 2024
Revision 2

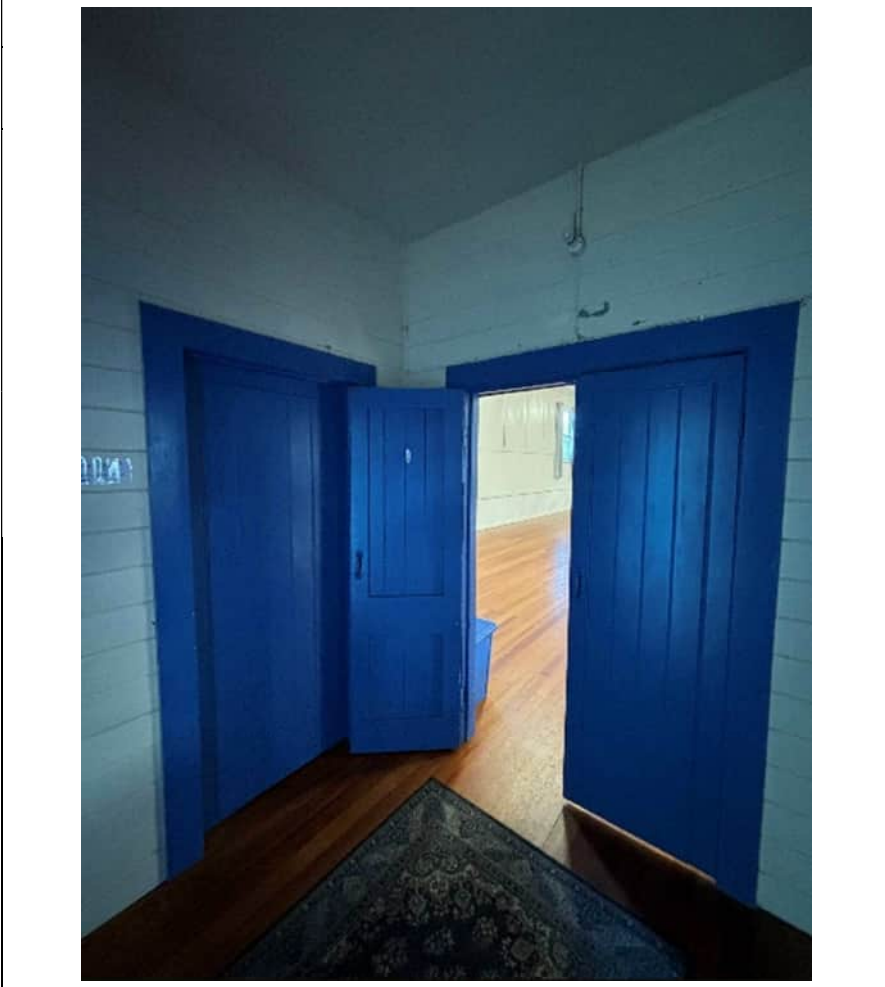
<p>Timber TG&V wall linings</p>	<p>Exceptional</p>	<p>The TG&V wall linings of the foyer are exceptional. Screwing the linings in place would result in the loss of associated wall linings and pre-bored timber holes. Holes would be filled to complete the linings. The work is minimal. The work is proposed.</p>
	<p>Ticket office hatch</p>	<p>Exceptional</p>	<p>The hatch is exceptional. The hatch is proposed to be replaced by the proposed work.</p>

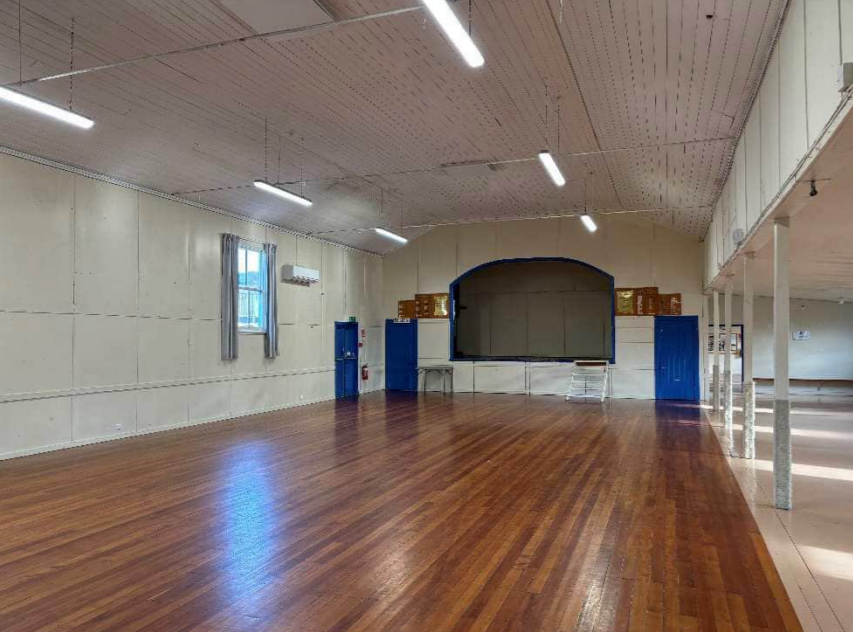
Timber TG&V vaulted ceiling	Exceptional	<p>The timber TG&V ceiling linings are original historic fabric that remain largely unaltered since the building's construction.</p> <p>The drawings indicate that the wall linings on gridline A are to be screwed to each framing member. Screwing the TG&V will create multiple holes in the fabric and there is a risk of associated damage if the boards are highly brittle. Screw holes are to be pre-bored to prevent splitting, and screws installed to allow flush finishing of holes. Holes are to be filled and sanded, and the wall repainted. Once complete the work should not be visible, and the overall fabric loss is small. Therefore, the adverse effect of the screwing is negligible.</p> <p>To secure the perimeter of the wall to the ceiling, it is proposed to install new light gauge steel angle braces. The drawings indicate that these are to be fixed through the TG&V, and are to be hidden by a new scotia. Provided that they are properly concealed, the adverse effect of the angle braces should be negligible.</p> <p>The two new steel portal frames will be exposed and visible below the ceiling. They will be painted. This is considered to align with the simple and functional aesthetic of the building, and is an honest expression of the structural intervention being undertaken. Therefore, this approach is acceptable. The drawings also indicate that penetrations through the TG&V ceiling linings will be required at the haunch junctions of the portal frames for fly braces that are to be fixed to the roof framing. Cutting back the ceilings to allow for installation of these braces could cause undue damage and result in an unsightly finish if not undertaken carefully. There is nothing in the drawings that addresses this issue, which would have a moderate adverse impact.</p>	Negligible Adverse Negligible Adverse Moderate Adverse	<p>The condition of the existing fabric should be photographically recorded prior to, during, and at completion of the works.</p> <p>The existing scotia mouldings should be carefully removed and reinstated over the brackets, rather than being replaced with new. An additional piece may need to be added if the scotia is not large enough to conceal the brackets entirely.</p> <p>If it is possible to change the design of the portal frames to remove the fly braces, then this should be done. If the fly braces are removed entirely the impact of the portal frames on the ceiling would be reduced to negligible adverse.</p> <p>If it is not possible to change the design to remove these fly braces, then the works should be carried out following a methodology that has been approved by a heritage specialist. If this recommendation is followed the adverse effect will be reduced to minor.</p>

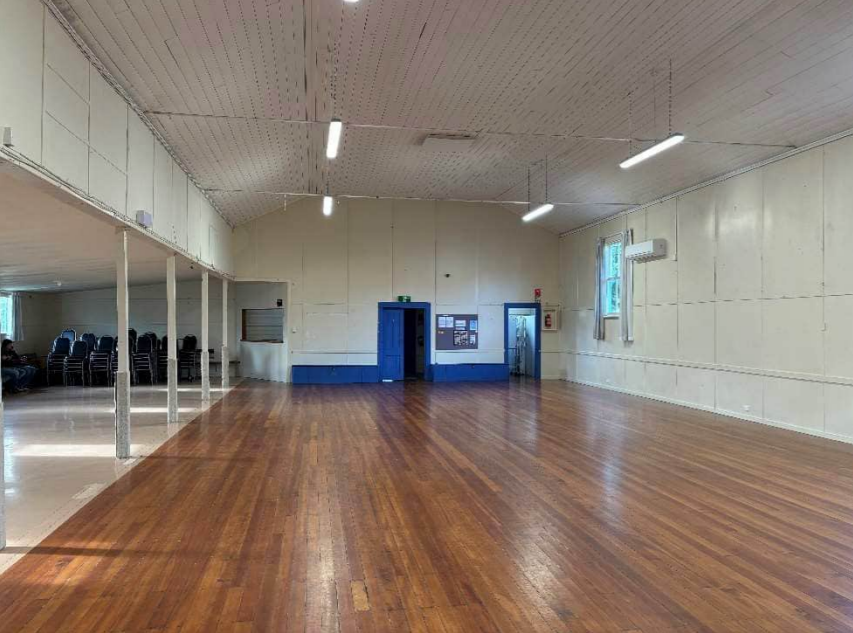
Steel tie rods	High	<p>The tie rods are assumed to be an historic feature of the building. They are to remain insitu.</p>	Neutral	
	Softboard ("Beautyboard") wall linings, timber dado rails and timber skirting boards to wall on gridline A	Intrusive	<p>It is assumed that these linings were applied over the original timber TG&V linings in the 1970s, either for aesthetic or acoustic reasons. They are to be removed and disposed of.</p>	Moderate Beneficial

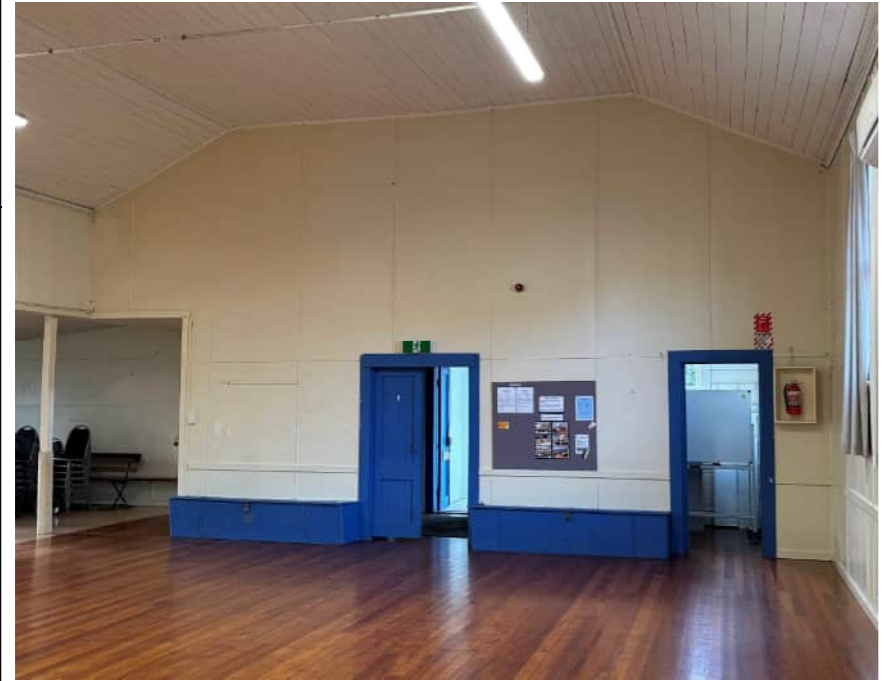
Softboard ("Beautyboard") wall linings, timber dado rails and timber skirting boards to wall on gridline 2	Intrusive	It is assumed that these linings were applied over the original timber TG&V linings in the 1970s, either for aesthetic or acoustic reasons. They are to be removed and disposed of.	Moderate Beneficial	<p>Seajay Consulting should confirm whether it is possible to achieve the required bracing using the same TG&V screw-fixing methodology as the wall on gridline A, noting that both sides of the wall are lined with TG&V that could be screw fixed.</p>
	Timber TG&V wall linings to wall on gridline 2 (assumed below softboard)	Exceptional	<p>Based on the extant wall linings in other areas of the building, it is assumed that the walls of the hall were originally lined in horizontal TG&V boards; and that the current softboard wall linings have been applied over this TG&V.</p> <p>The proposed strengthening scheme requires this wall to be over-lined in GIB Braceline. Drawing S1 also states (at note 57) that a 12mm thick plywood dado is to be applied to the walls abutting the GIB board. This will cause additional and unnecessary damage to the TG&V and continue the concealment of original fabric, which together have a minor adverse impact.</p> <p>There is no mention of a scotia or equivalent moulding to conceal the wall-to-ceiling junction.</p>	Minor Adverse	<p>If this is possible, and the TG&V is in reasonable condition, it should be left exposed. As for TG&V linings in the foyer, screw holes should be pre-bored to prevent splitting, and screws installed to allow flush finishing of holes. Any nails left embedded in the TG&V from the softboard linings should be removed. All holes should be filled and sanded, and the wall repainted. Once complete the work should not be visible, and the overall fabric loss is small.</p> <p>If this recommendation is followed, the adverse effect would be reduced to negligible.</p> <p>Regardless of the outcome of the above, the condition of the existing fabric should be photographically recorded prior to, during, and at completion of the works. New materials should be date stamped.</p>

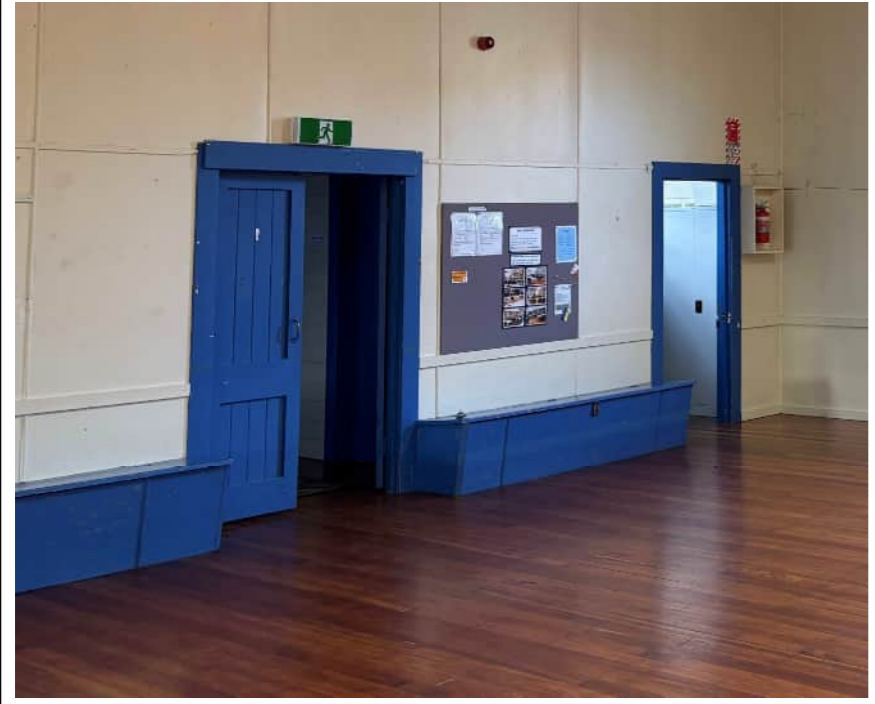
<p>Timber frame & ledger doors to cloakroom and to foyer, including frames and architraves</p>	<p>Exceptional</p>	<p>These doors, including frames and architraves) are original fabric. Architraves around these doors will need to be removed for works to the wall linings. Note 56 on drawing S1 states that new architraves are to be installed.</p> <p>Refer above for comment regarding handles to the double doors to the foyer.</p>	<p>Minor Adverse</p>	<p>It is recommended that the existing architraves are carefully removed, retained, and reinstated at completion of works to the wall. This would reduce the adverse effects to negligible.</p> <p>Note that some packing may be required to take up differential wall and door frame thicknesses due to changes in the linings. This should be carried out in timber, and a 2mm (approx.) quirk incorporated between the packing and the frame and between the packing and architraves.</p> <p>Regardless of the outcome of the above, the condition of the existing fabric should be photographically recorded prior to, during, and at completion of the works. New materials should be date stamped.</p>

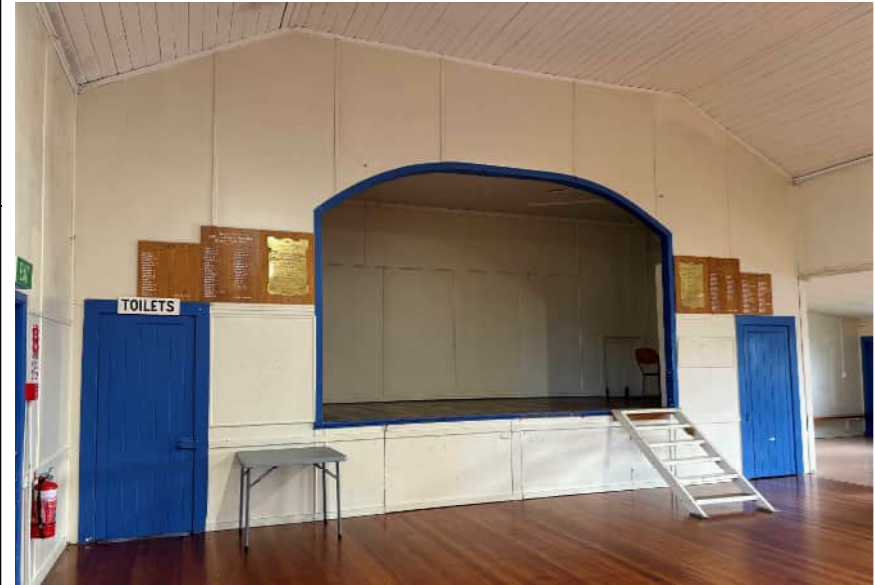
<p>Softboard ("Beautyboard") wall linings, timber dado rails and timber skirting boards to wall on gridline 6</p>	<p>Intrusive</p>	<p>It is assumed that these linings were applied over the original timber TG&V linings in the 1970s, either for aesthetic or acoustic reasons. They are to be removed and disposed of.</p>	<p>Moderate Beneficial</p>	<p><u>Seajay Consulting should confirm whether it is possible to achieve the required bracing using the same TG&V screw-fixing methodology as the wall on gridline A, noting that both sides of the wall are lined with TG&V that could be screw fixed.</u></p>

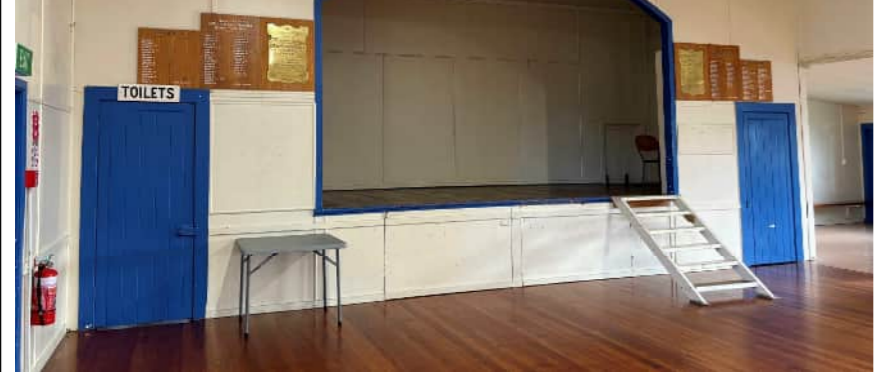
<p>Timber TG&V wall linings around proscenium on gridline 6 (assumed below softboard)</p>	<p>Exceptional</p>	<p>Based on the extant wall linings in other areas of the building, it is assumed that the walls of the hall were originally lined in horizontal TG&V boards; and that the current softboard wall linings have been applied over this TG&V.</p> <p>The proposed strengthening scheme requires new strip braces and hold-down brackets to be installed to the wall framing. Doubling of wall studs may also be required (if there are not double studs in situ). Although no mention of the existing TG&V linings is made in the documents, this work will require the existing linings to be removed. This removal of original fabric of exceptional significance will have a moderate adverse impact.</p> <p>Once the works to the framing have been undertaken, it is proposed to line the wall in 12mm plywood with 10mm GIB Standard over, except below the stage where it will be GIB Fyreline over (as the area below the stage is required to be fire rated according to the fire report). Drawing S1 also states (at note 57) that a 12mm thick plywood dado is to be applied to the walls abutting the GIB board.</p> <p>There is no mention of a scotia or equivalent moulding to conceal the wall-to-ceiling junction, nor is there any mention of the frame around the proscenium.</p> <p>Currently, there are two doors opening into the under-stage area. These are proposed to be completely removed, new wall framing installed, and a new hatch access in the wall under the stage is also proposed. The hatch will be fire rated, as per the wall below the stage.</p>	<p>Moderate Adverse</p>	<p><u>If this is not possible, then Seajay Consulting should confirm whether the required bracing can be achieved if the plywood is installed on the stage-side of the wall rather than the hall-side,</u> noting that the ceiling of the stage is lower than the ceiling of the hall and, ideally, this should not be disturbed.</p> <p>If either of these are possible, and the TG&V lining on the hall-side of the wall is in reasonable condition, it should be left exposed. As for TG&V linings in the foyer, screw holes should be pre-bored to prevent splitting, and screws installed to allow flush finishing of holes. Any nails left embedded in the TG&V from the softboard linings should be removed. All holes should be filled and sanded, and the wall repainted. Once complete the work should not be visible, and the overall fabric loss is small. This would reduce the adverse impact of the works to negligible adverse (if there is no relining) or minor adverse (if the stage-side of the wall is relined).</p> <p>Regardless of the outcome of the above, the condition of the existing fabric should be photographically recorded prior to, during, and at completion of the works. New materials should be date stamped.</p>

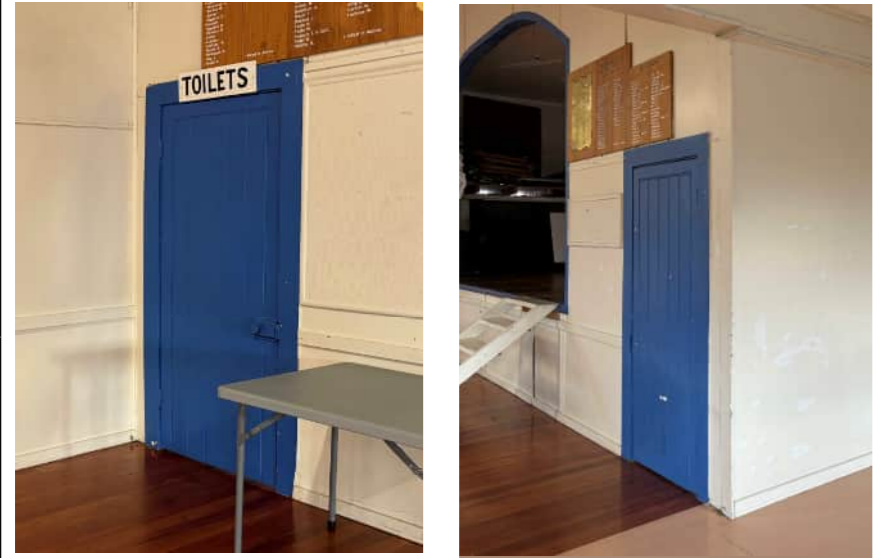
Timber frame & ledger doors either side of stage, including frames and architraves	Exceptional	<p>These two symmetrically placed doors, including frames and architraves) are original fabric. They give access either side of the stage when the floor wings are folded up.</p> <p>The door on the northeast side now provides access from the main hall to the rear of the building where the toilets are located. The Accessibility Report states that the handles to the door on the northeast side of the stage (accessing the corridor to the toilets) must be replaced with compliant lever-type handles. It appears that this door retains its original hardware, although it has been painted. Loss of the original hardware is a negligible adverse effect.</p> <p>Architraves around both these doors will need to be removed for works to the wall linings. Note 56 on drawing S1 states that new architraves are to be installed. Loss of the original architraves and necessary adjustment to the doors will be a minor adverse effect.</p>	<p>Negligible Adverse</p> <p>Minor Adverse</p>	<p>The original hardware should be retained for possible future reinstatement or use on another original door.</p> <p>The door on the southwest side, which will give access to a new accessible stair, currently has no hardware; however, no new hardware has been proposed for this door in the Accessibility Report or other documents.</p> <p>It is recommended that the existing architraves are carefully removed, retained, and reinstated at completion of works to the wall. This would reduce the adverse effects to negligible.</p> <p>Note that some packing may be required to take up differential wall and door frame thicknesses due to changes in the linings. This should be carried out in timber, and a 2mm (approx.) quirk incorporated between the packing and the frame or between the packing and architraves.</p> <p>Regardless of the outcome of the above, the condition of the existing fabric should be photographically recorded prior to, during, and at completion of the works. New materials should be date stamped.</p>

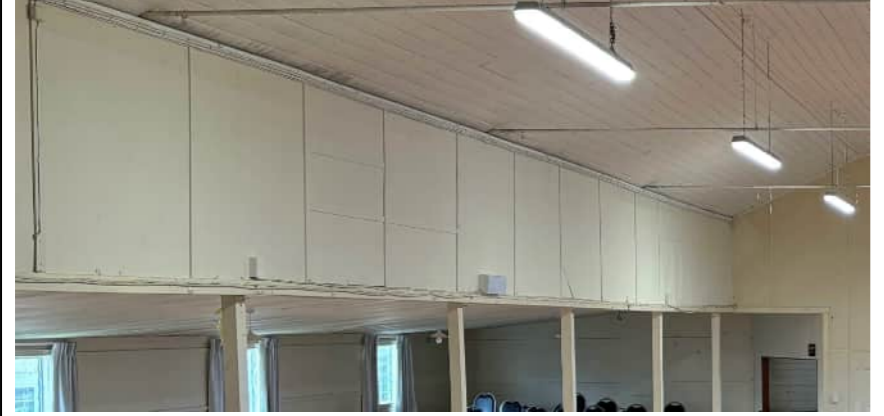
Softboard ("Beautyboard") wall linings to wall on gridline C (above beam)	Intrusive	It is assumed that these linings were applied over the original timber TG&V linings in the 1970s, either for aesthetic or acoustic reasons. No work is being proposed to this wall insofar as it is or will be visible within the main hall.	Neutral	<p>This wall was originally lined in horizontal TG&V boards; and that the current softboard wall linings have been applied over this TG&V. It is recommended that the softboard linings are removed and the TG&V repaired and repainted. This would have a moderate beneficial effect.</p> <p>The condition of the existing fabric should be photographically recorded prior to, during, and at completion of the works.</p>

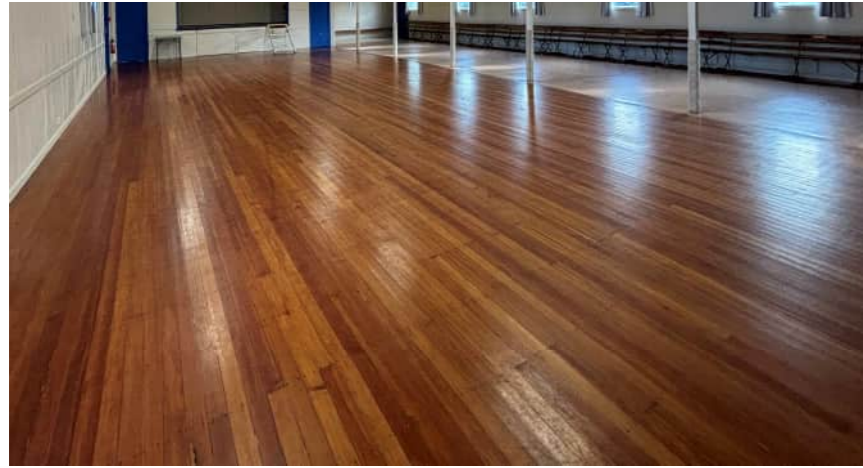
Timber T&G floorboards	Exceptional	The floorboards are an original feature of the building and are in good condition. The drawings indicate that there will be new footings and pads for the portal frames on gridlines A and C, three further new pads on gridline C, and anchor piles along gridline 2 below the wall line and threshold of the doors to the foyer and cloakroom, and braced piles on gridline 6 below the stage edge. Floorboards will need to be lifted to get access for installing these new foundations. Damage to, or loss of, this original fabric will be a moderate adverse effect.	Moderate Adverse	The condition of the existing fabric should be photographically recorded prior to, during, and at completion of the works. If possible, access to the foundations on gridline C should be created through the floor of the annex and the work undertaken without touching timber floorboards. Floorboards should be carefully removed in full lengths only, and should be reinstated in their original locations, with all works carried out following a methodology that has been approved by a heritage specialist. If this recommendation is followed, and the methodology is carefully carried out by the contractor, the disturbed areas should not be visible, and the adverse effect would be reduced to negligible.

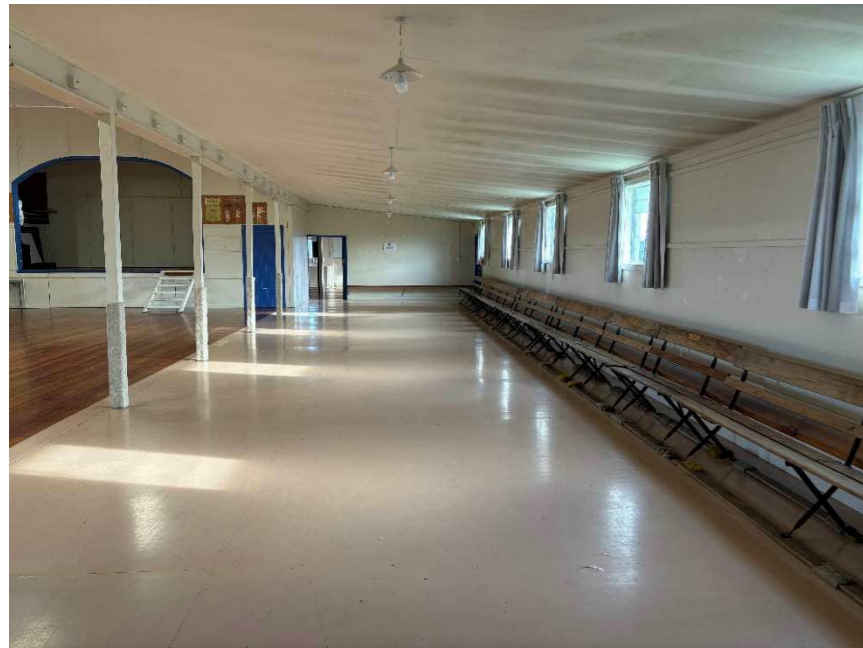
Ceiling linings (softboard or similar)	Little	While the linings are part of the 1970s addition, they make little contribution to understanding the significance of the place in and of themselves. They are also in poor condition.	Neutral	The condition of the existing fabric should be photographically recorded prior to, during, and at completion of the works.
	Softboard wall linings	Little	No work is proposed that will impact the existing ceiling linings, or the wall linings on gridlines 1, 7 and D, other than the new wall on gridline 3. It is assumed that localised areas of lining will be cut back for installation of this wall. On gridline C (between gridlines 6 and 7) softboard linings will be removed from the wall to the stage and replaced with new plywood linings with GIB board over. Overall, this change will not be evident once it is completed, and is therefore considered to have a neutral effect. At the other end of the annex, a new wall is to be built on gridline C, which will have plywood linings with GIB board over. This wall is discussed as part of the ticket office.	Neutral	The drawings do not provide any detail regarding how the corner at the intersection of gridlines C and 6 is to be detailed for the cut edges of the new wall linings, and this should be addressed.

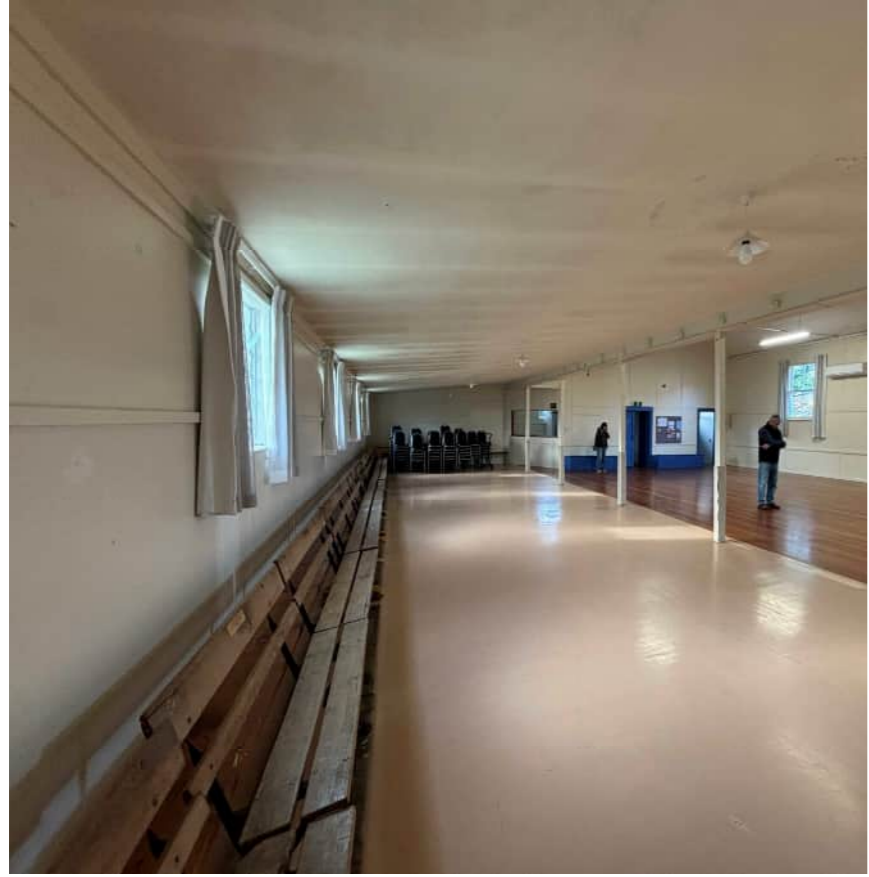
6 no. timber frame windows with glass louvres	Moderate	As a feature of both the interior and exterior of the 1975 addition, these windows make some contribution to the cultural heritage values of the building in their form and use. The louvres are assumed to be original; however, they are also in poor repair and are creating draught issues inside the building. If budget allows, the louvres are to be replaced with new fixed glazing in the existing timber frames, which will ensure retention and improve longevity of the frames.	Minor Beneficial	The condition of the existing fabric should be photographically recorded prior to and during the works.
	Painted floor (chipboard or similar)	Little	While the flooring is part of the 1970s addition, in and of itself it makes little contribution to understanding the significance of the place. It will be necessary to remove flooring along gridlines C and D for portal frame footings and pads, additional pads, and anchor piles. It is in poor condition, suffering from wear-and-tear as well as water damage. It is expected that the flooring removed will be replaced.	Neutral	While the impact on heritage values is neutral, it is recommended that the entire floor in the annex be replaced so that there are no patches that may appear untidy or create a trip hazard. The condition of the existing fabric should be photographically recorded prior to, during, and at completion of the works.

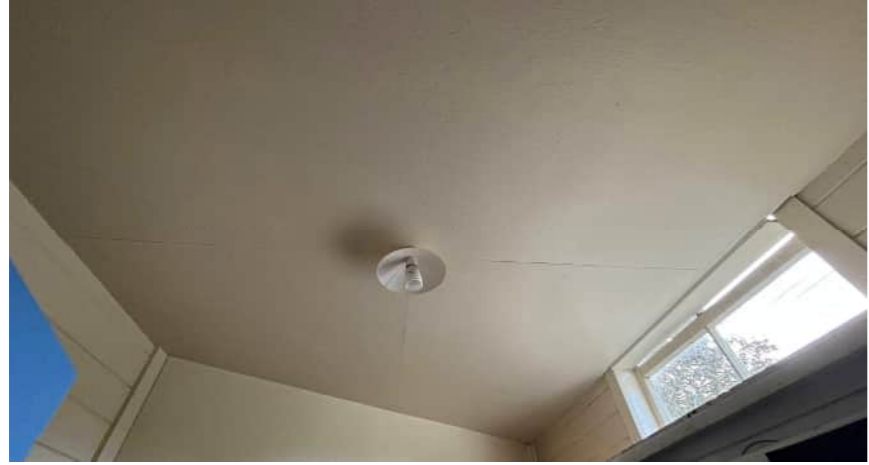
Ceiling linings and false ceiling structure	Intrusive	The false ceiling was installed in the 1970s when the annex was constructed. It extends out into the hall beyond the diagonal wall (in a rectangular shape). It conceals the walls above and cuts across the double-hung sash window; and, therefore, it is considered to be intrusive. No works to the ceiling itself are proposed.	Neutral	Removing the false ceiling should be considered as this would expose the full height of the window, as well as the walls and ceiling above, would have a moderate beneficial impact.
---	---	-----------	--	---------	--

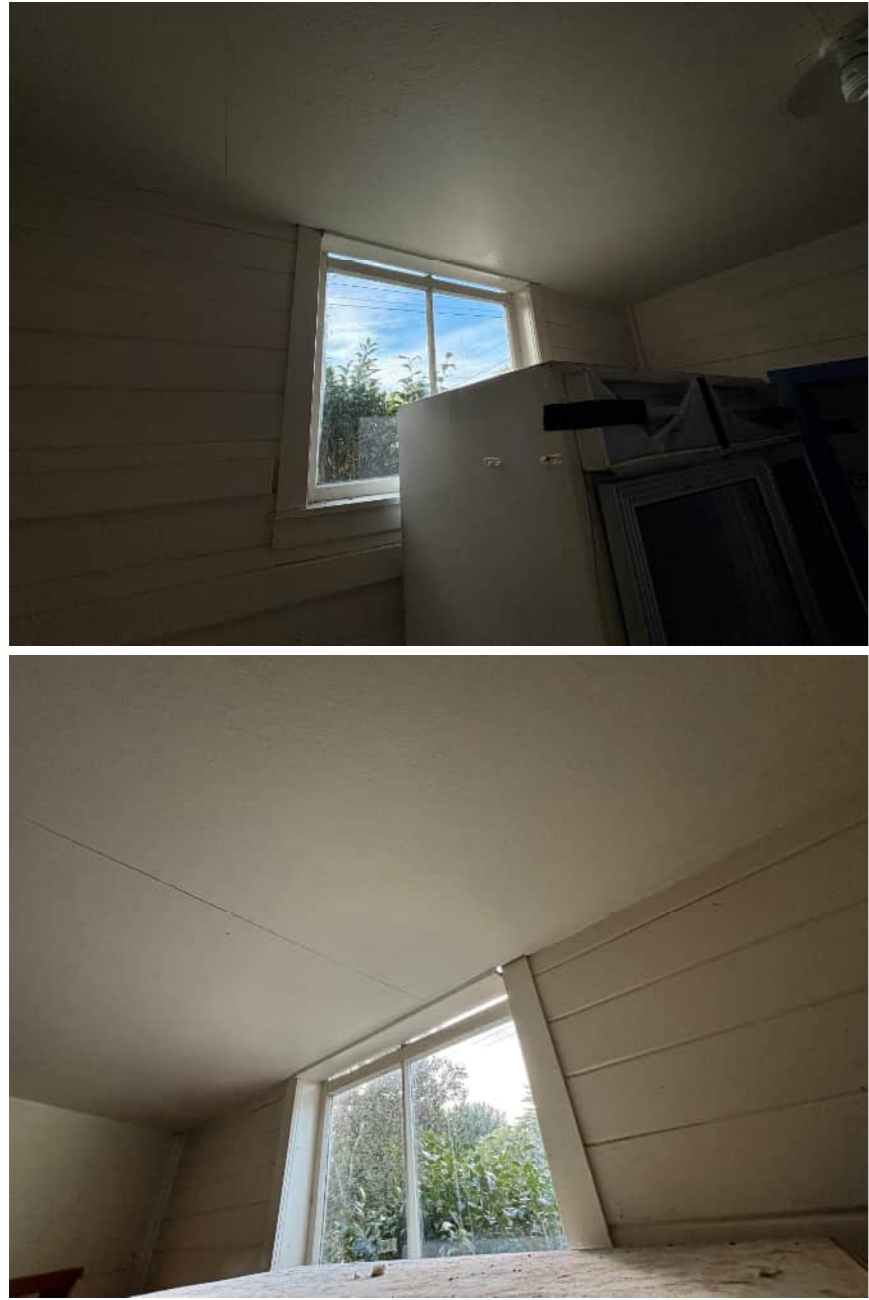
Timber TG&V wall linings	Exceptional	<p>The TG&V wall linings are an original feature.</p> <p>The drawings indicate that a new wall is to be constructed on gridline C, and it is assumed that this wall will infill the area between the floor and the beam/false ceiling only. The drawings also indicate that new plywood linings are to be installed on the face of this wall above the height of false ceiling. However, this does not take account of the TG&V linings in this area which presumably remain insitu and which would need to be removed. Although these linings may remain concealed above the false ceiling, they should be treated as per all of the other TG&V linings.</p>	Minor Adverse	<p>Seajay Consulting should confirm whether it is <u>possible to achieve the required bracing using the same TG&V screw-fixing methodology as the wall on gridline A.</u></p> <p>If this is possible, and the TG&V is in reasonable condition, it should be left exposed. As for TG&V linings in the foyer, screw holes should be pre-bored to prevent splitting, and screws installed to allow flush finishing of holes. Any nails left embedded in the TG&V from the softboard linings should be removed. All holes should be filled and sanded, and the wall repainted. Once complete the work should not be visible, and the overall fabric loss is small.</p> <p>If this recommendation is followed, the adverse effect would be reduced to negligible.</p> <p>Regardless of the outcome of the above, the condition of the existing fabric should be photographically recorded prior to, during, and at completion of the works. New materials should be date stamped.</p>

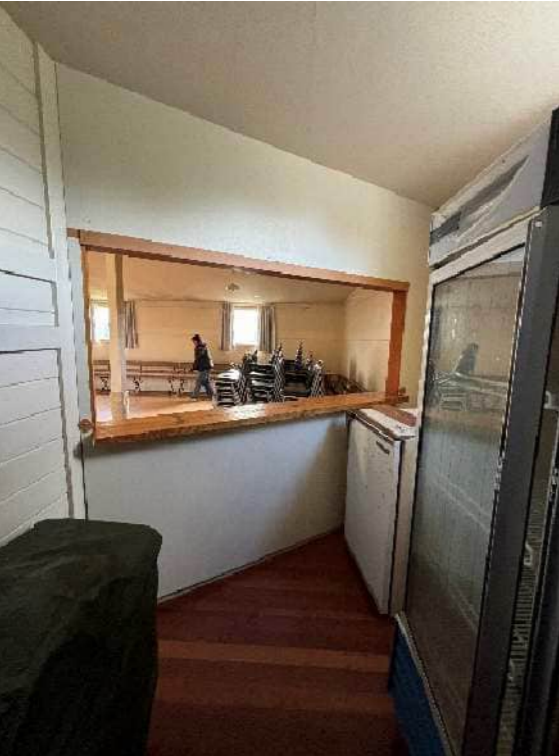
New wall on gridline 2	N/A	A small length of wall on gridline 2 is to be installed to restore the ticket office to its original rectangular shape. The drawings state that this is “to match existing”. Reinstatement of the wall is a beneficial effect as it restores the original wall line; however, there are no details of the wall linings or finishes.	Unknown	<p>The condition of the existing fabric should be photographically recorded prior to, during, and at completion of the works.</p> <p>Assuming that the recommendation above to restore the TG&V linings on this wall is followed, the new area of wall should be lined with TG&V salvaged from other parts of the building (for example, the wall on gridline 6) where TG&V has to be removed.</p> <p>New materials should be date stamped.</p>
	New servery on gridline 2	N/A	It is proposed to create a servery to the ticket office in this wall. This will require removal of fabric from the original wall, which is an adverse effect. The drawings do not include any detail about the servery in terms of its frame, architraves, or sill.	Minor Adverse	<p>It would be preferable to position the servery in the section of new wall to be constructed, that way any loss of existing fabric would be avoided, and the adverse impact would be reduced to negligible.</p> <p>The servery opening should be framed in timber, have architraves that match those of the adjacent doors on both sides, and be painted out to match other timberwork.</p>

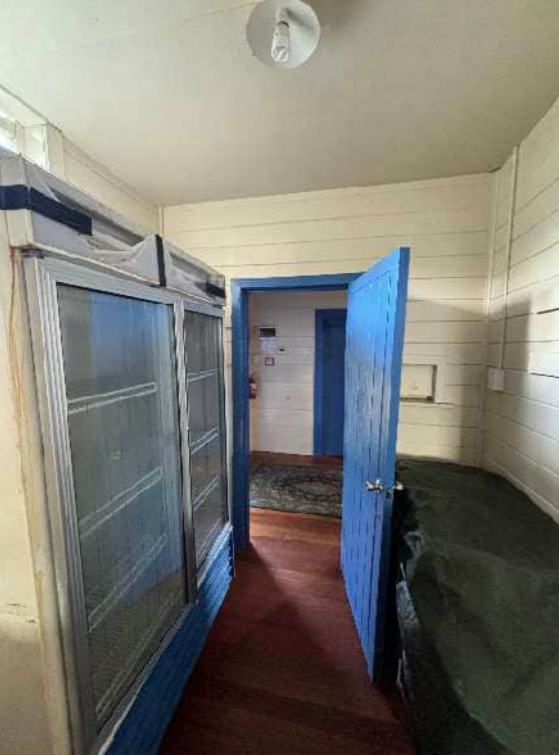
Timber frame & ledger door to main hall and door to foyer, including frames and architraves	Exceptional	The door (including frames and architraves) is original fabric. No work is proposed to the door, frame or architraves.	Neutral	
	Ticket office hatch	Exceptional	The hatch is a unique original feature of the building and will not be altered by the proposed works.	Neutral	
	Coat hook rails	Exceptional	These are original fabric, and will not be impacted by the proposed works.	Neutral	
	Timber T&G floorboards	Exceptional	The floorboards are an original feature of the building and are in good condition. The drawings indicate that there will be a new pad at the intersection of gridlines C and 1. Floorboards may need to be lifted to get access for installing these new foundations. Damage to, or loss of, this original fabric will be a moderate adverse effect.	Moderate Adverse	<p>The condition of the existing fabric should be photographically recorded prior to, during, and at completion of the works.</p> <p>If possible, access to this area should be created through the floor of the annex and the work undertaken without touching timber floorboards.</p> <p>If this recommendation is followed, and the methodology is carefully carried out by the contractor, the disturbed areas should not be visible, and the adverse effect would be reduced to negligible.</p>

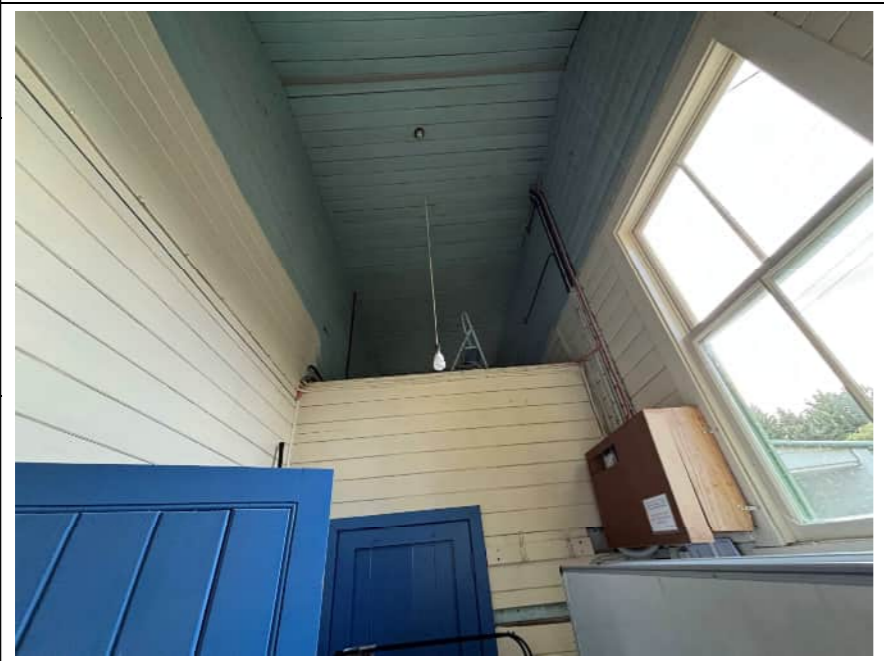
TG&V ceiling linings	Exceptional	The timber TG&V ceiling linings are original historic fabric that remain largely unaltered since the building's construction. No work is to be undertaken that will affect the ceiling.	Neutral	
	Timber TG&V wall linings	Exceptional	The TG&V wall linings are an original feature. The drawings indicate that the wall linings on gridline 1 are to be screwed to each framing member. Screwing the TG&V will create multiple holes in the fabric and there is a risk of associated damage if the boards are highly brittle. Screw holes are to be pre-bored to prevent splitting, and screws installed to allow flush finishing of holes. Holes are to be filled and sanded, and the wall repainted. Once complete the work should not be visible, and the overall fabric loss is small. Therefore, the adverse effect is negligible.	Negligible Adverse	The condition of the existing fabric should be photographically recorded prior to, during, and at completion of the works. This rating assumes that note 55 on drawing S1 does not apply to the wall on gridline 1. The wall should not be over-lined with GIB board or any other lining. Therefore, no architraves are required to be removed or replaced, and no packing of frames is required.

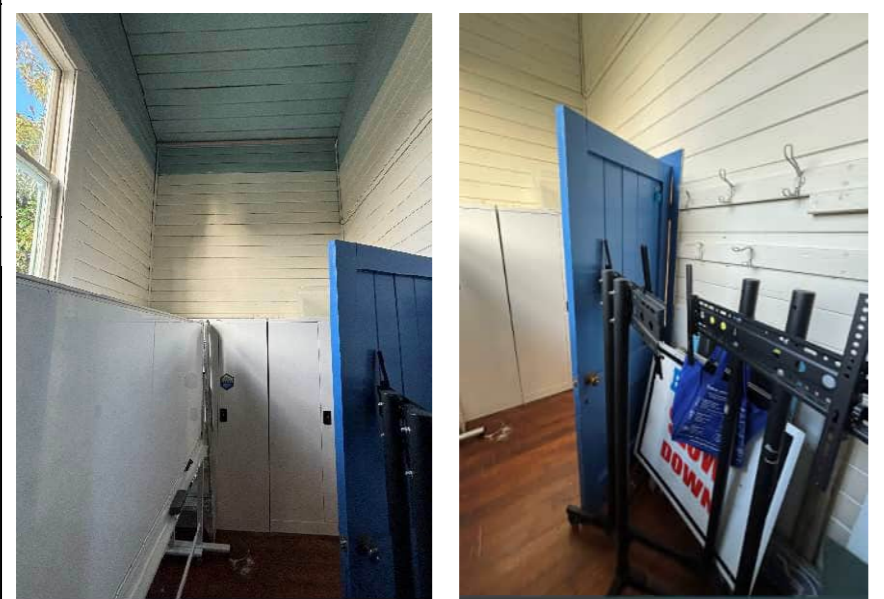
Timber frame & ledger door to main hall and door to foyer, including frames and architraves	Exceptional	Both doors (including frames and architraves) are original fabric. No work is proposed to the doors, frames or architraves in this area.	Neutral	
	Coat hooks and rails	Exceptional	These are original fabric, and will not be impacted by the proposed works.	Neutral	
	Timber T&G floorboards	Exceptional	The floorboards are an original feature of the building and are in good condition. The drawings indicate that there will be new anchor piles along gridline 2 below the wall line and threshold of the door to the main hall. Floorboards will need to be lifted to get access for installing these new foundations. Damage to, or loss of, this original fabric will be a moderate adverse effect.	Moderate Adverse	The condition of the existing fabric should be photographically recorded prior to, during, and at completion of the works. Floorboards should be carefully removed in full lengths only, and should be reinstated in their original locations, with all works carried out following a methodology that has been approved by a heritage specialist. If this recommendation is followed, and the methodology is carefully carried out by the contractor, the disturbed areas should not be visible, and the adverse effect would be reduced to negligible.

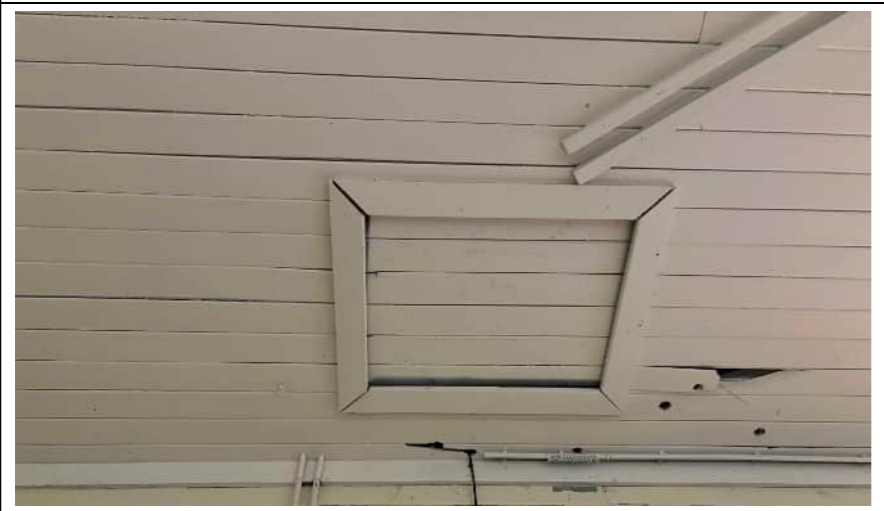
TG&V ceiling linings	Exceptional	<p>The flat ceiling over the stage is lower than the vaulted ceiling over the main hall, but is also lined with timber TG&V which is original fabric. The ceiling incorporates an access hatch to the roof space.</p> <p>No work is proposed to the ceiling itself, but rectangular trims at the wall-to-ceiling junctions will need to be removed for wall lining works. Further, as the ceiling above the stage is lower than the vaulted ceiling of the main hall, it may need to be cut back to allow for fixings for new linings to be installed to walls on gridlines 6 and C.</p>	Minor Adverse	<p>The condition of the existing fabric should be photographically recorded prior to, during, and at completion of the works.</p> <p>If all relining works can be undertaken in a way that avoids damaging the ceiling, the adverse effect will be reduced to neutral.</p>

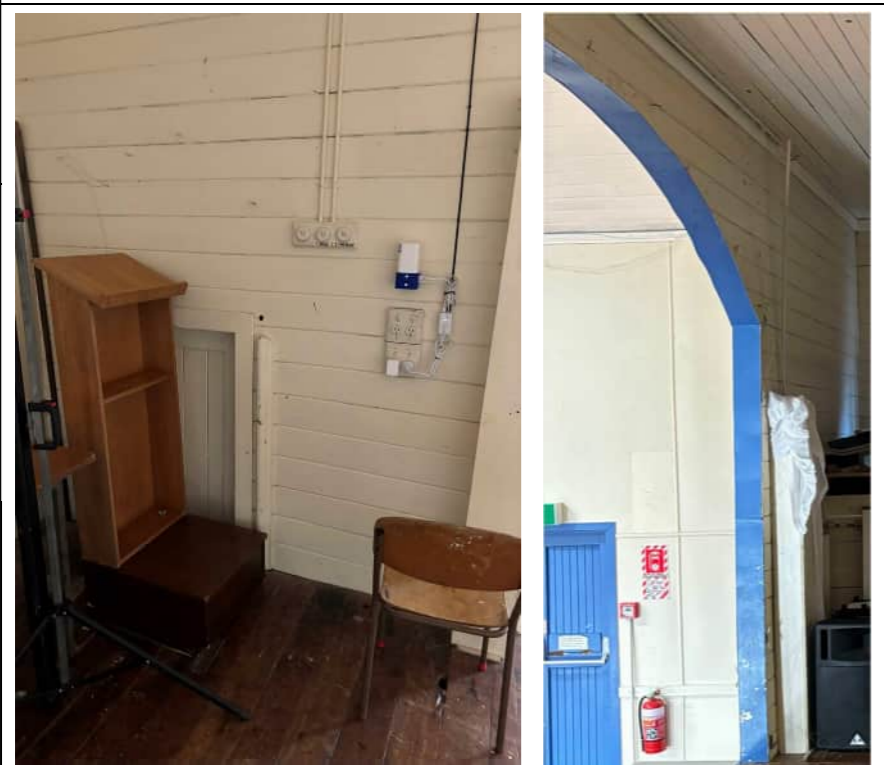
Timber TG&V wall linings around proscenium on gridline 6 (assumed below softboard)	Exceptional	Refer to the explanation and recommendations for the wall on gridline 6 of the main hall.		Adding plywood linings to this side of the wall will have a lesser impact than adding them to the hall-facing side, if they are required.
	Proscenium frame	High	It is assumed that the current frame to the proscenium is historic fabric, although it may not be original. It is also in poor condition. The documents do not address what is to be done with this frame; however, it is likely that it will need to be made wider to accommodate changes to the wall linings. As this will involve loss of the historic fabric, and no replacement has been specified, there will be a minor adverse impact.	Minor Adverse	<p>The frame to the proscenium should be replaced in like-for-like materials with increased width if this is required to take up the depth of additional wall linings.</p> <p>Regardless of the outcome of the above, the condition of the existing fabric should be photographically recorded prior to, during, and at completion of the works. New materials should be date stamped.</p>

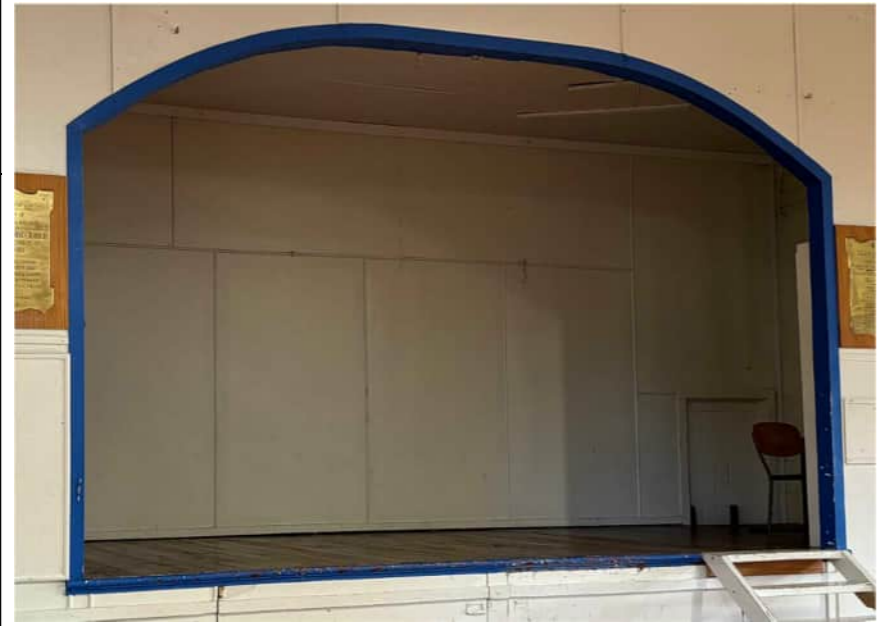
Softboard ("Beautyboard") wall linings, battens and skirting boards to wall on gridline 7	Intrusive	Based on the extant wall linings in other areas of the building, it is assumed that the walls of the hall were originally lined in horizontal TG&V boards; and that the current softboard wall linings have been applied over this TG&V.	Neutral	It is recommended that the softboard linings be removed and the TG&V linings be restored. Any nails left embedded in the TG&V from the softboard linings should be removed. All holes should be filled and sanded, and the wall repainted. This would result in a moderate beneficial impact.
	Timber TG&V linings to wall on gridline 7 (assumed below softboard)	Exceptional	The proposed strengthening scheme requires a layer of GIB board to be added to one side of this wall, with GIB grabber high thread screw fixings in accordance with the GIB EzyBrace Systems specification. The documents do not specify which side of the wall the GIB is to be fixed to, but it is assumed that it would be applied to the anteroom side. Therefore, no works are being proposed linings on the stage side.		Regardless of the outcome of the above, the condition of the existing fabric should be photographically recorded prior to, during, and at completion of the works. New materials should be date stamped.

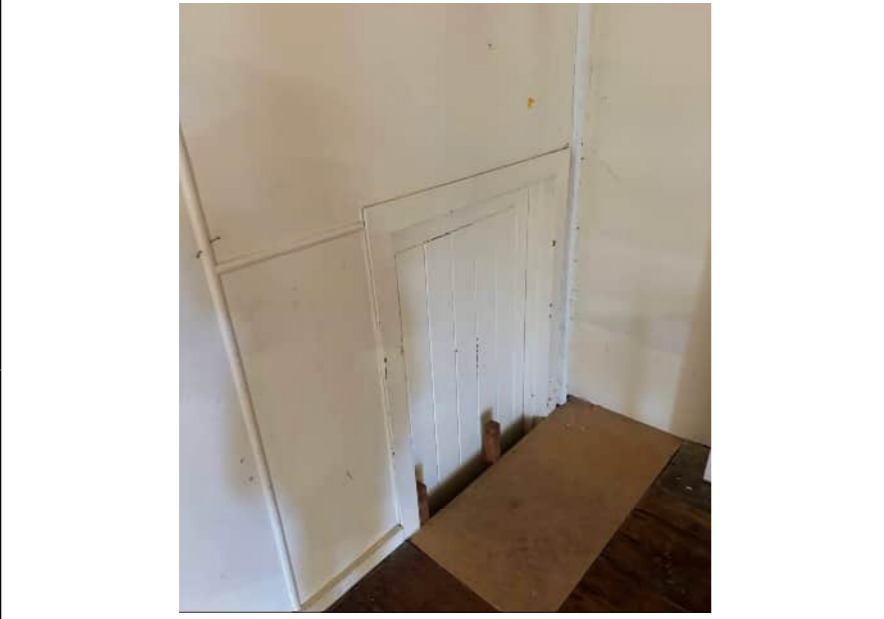
Timber frame & ledger door to anteroom, including frame and architraves	Exceptional	<p>This door, including frames and architraves) is original fabric. It is proposed that this door be removed, and the opening infilled as an accessible stair is to be installed in the location of the stage wing and there will no longer be access through this side of the stage. The (assumed) corresponding door on the northeast side of the stage has been removed (refer description of opening below). This being the case, and noting that the door is primarily used for accessing the under-stage area while the southwest wing is permanently folded down, removal of this door and associated loss of original fabric will have a moderate adverse impact, but will be aligned with future building use requirements.</p> <p>The documents do not address what wall linings are to be installed over this opening once the door is removed (assuming that the GIB board identified for bracing is to be installed on the anteroom side of the wall on gridline 7 in accordance with above).</p>	Moderate Adverse	<p>The condition of the existing fabric should be photographically recorded prior to, during, and at completion of the works.</p> <p>The door, including frame and architraves, should be carefully removed and, if it is not to be reused in the building at the present time, it should be retained and stored onsite in conditions that will ensure it does not deteriorate so that it may be reused in the future. This will not mitigate the adverse impact, but will assist in making it reversible.</p> <p>Assuming that the recommendation above to restore the TG&V linings on this wall is followed, the new area of wall where the door is removed should be lined with TG&V salvaged from other parts of the building (for example, the wall on gridline 6) where TG&V has to be removed. New materials should be date stamped.</p>

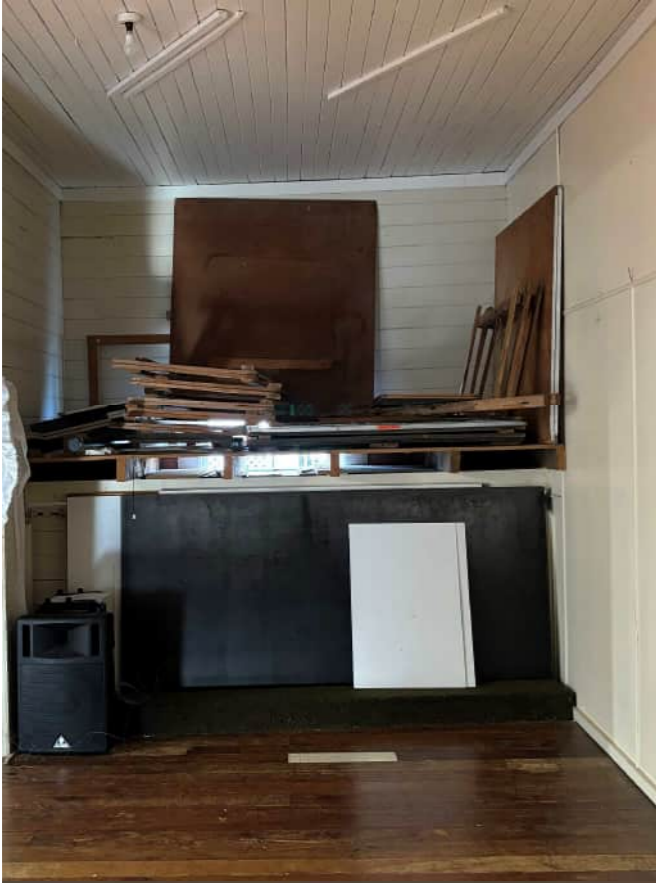
False ceiling of corridor	Intrusive	<p>This false ceiling is assumed to have been added in the 1970s as part of creating a corridor alongside the stage. It cuts across the double-hung sash window, and prevents the stage from operating as it was designed to do when the wing at this end was lowered.</p> <p>No work to this ceiling is proposed in the documents; however, it is not clear whether the wall that is proposed to formally separate the corridor and the stage is to be taken to full height, which would impact on the structure of this ceiling and the junction at the wall.</p>	Neutral	<p>It is recommended that the wall is taken up to full height, and the false ceiling is removed entirely. If this recommendation is followed the result would be a minor beneficial effect.</p> <p>Regardless of the outcome of the above, the condition of the existing fabric should be photographically recorded prior to, during, and at completion of the works. New materials should be date stamped.</p>
