Te Horo Hall

Seismic Strengthening Assessment of Effects on Historic Fabric

16 July 2024
Revision 2

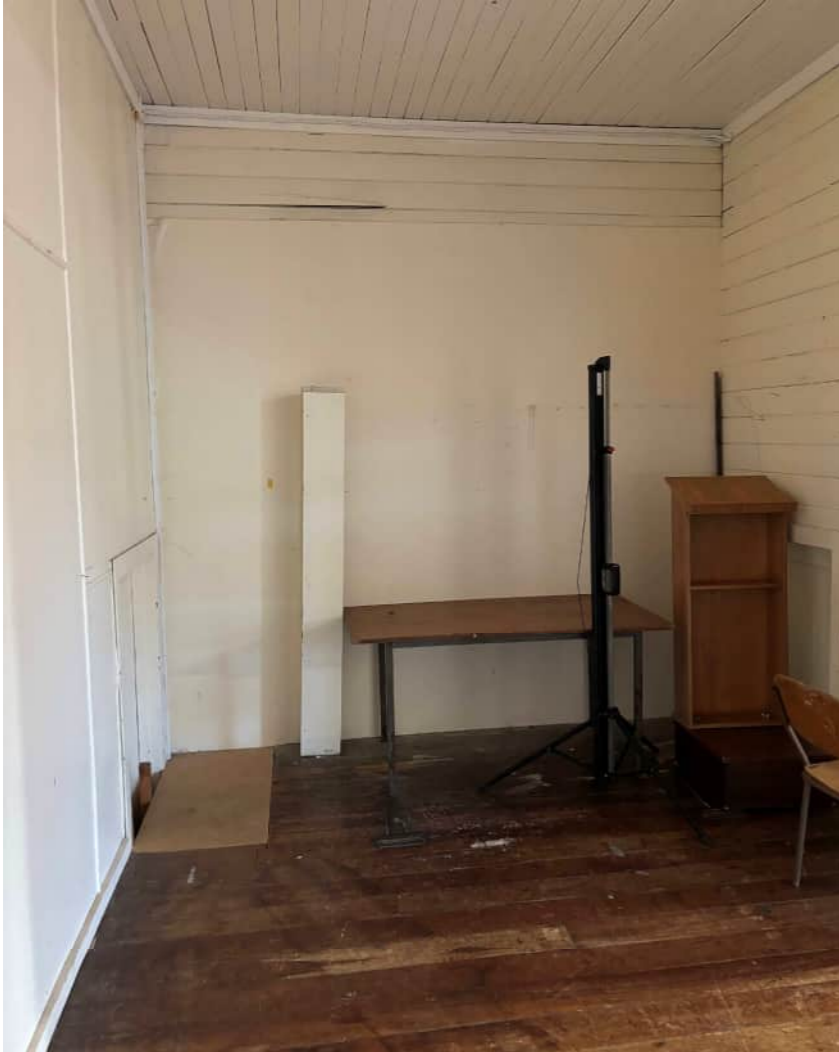
Softboard ("Beautyboard") wall linings, partial height, to gridline C	Intrusive	It is assumed that these linings were applied over the original timber TG&V linings in the 1970s, either for aesthetic or acoustic reasons. They are to be removed and disposed of.	Moderate Beneficial	
	Timber TG&V linings to wall on gridline C	Exceptional	<p>These wall linings are original fabric. Incorporated into the wall is a ledge upon which the joists of the foldable stage wing rest when it is lowered, which is part of the original stage design and has exceptional significance.</p> <p>The proposed strengthening scheme requires this wall to be over-lined in 12mm plywood for bracing purposes. The drawings show that the plywood would extend full height, from the main floor (not the raised stage) up to the underside of the building rafters. New straps, stud locks and brackets are incorporated, which will require access to the wall frame.</p> <p>While the alterations to the frame can be undertaken from the opposite side of the wall, meaning the existing TG&V linings can remain insitu, this will cause additional and unnecessary damage to the TG&V and continue the concealment of original fabric, which together have a minor adverse impact.</p>	Minor Adverse	<p><u>Seajay Consulting should confirm whether it is possible to achieve the required bracing using the same TG&V screw-fixing methodology as the wall on gridline A</u>, noting that further bracing units may be provided on the other side of the wall where no significant fabric will be impacted.</p> <p>If this is possible, and the TG&V is in reasonable condition, it should be exposed. As for TG&V linings in the foyer, screw holes should be pre-bored to prevent splitting, and screws installed to allow flush finishing of holes. Any nails left embedded in the TG&V from the softboard linings should be removed. All holes should be filled and sanded, and the wall repainted. Once complete the work should not be visible, and the overall fabric loss is small.</p> <p>If this recommendation is followed, the adverse effect would be reduced to negligible.</p> <p>If this is not possible, the TG&V wall linings and, most importantly, the ledge on which the folding stage wing rests, must remain insitu below the plywood.</p> <p>Regardless of the outcome of the above, the condition of the existing fabric should be photographically recorded prior to, during, and at completion of the works. New materials should be date stamped.</p>

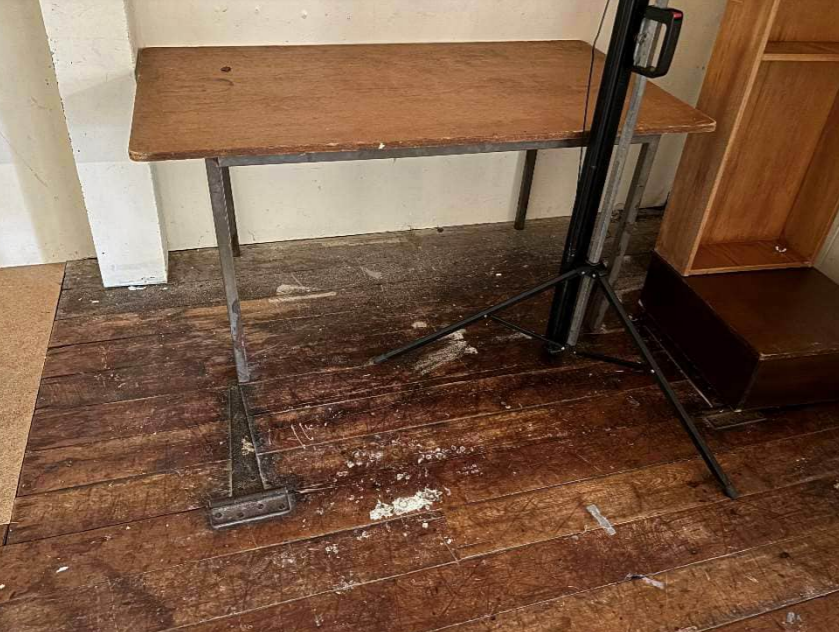
Foldable stage wing, SW end (abutting gridline C) including joists and floorboards	Exceptional	<p>The foldable stage wings are one of the building's most unique original features, and have exceptional significance. This wing was folded down at the time of inspection, and the presence of a small piece of particle board infill adjacent to the door to the anteroom suggests that it remains down permanently.</p> <p>It is proposed to remove this stage wing for construction of an accessible stair and landing behind the door to the main hall, including a new wall to close off the edge of the stage and extending up to a height of 1m above the stage floor level.</p> <p>Removal of stage wing and associated loss of original fabric will have a moderate adverse impact, while construction of the stairs and a wall with integrated barrier to the side of the stage will also have an adverse impact by intruding into what was previously usable stage space. However, these changes will be aligned with future building use requirements.</p>	Moderate Adverse	<p>The condition of the existing fabric should be photographically recorded prior to, during, and at completion of the works.</p> <p>The folding wing, including joists, floorboards, and associated hardware, should be carefully removed, retained and stored onsite, in conditions that will ensure it does not deteriorate, so that it may be reused in the future. This will not notably reduce the adverse impact; however, it will ensure that the alteration is reversible (assuming that the ledge remains in place on the wall on gridline A) which will provide some mitigation.</p> <p>The wall closing off the end of the stage, and extending up to form the barrier, should not encroach in any way on the fixed stage floor. No flooring of the existing stage, nor any of the subfloor structure, should be impacted by this wall, so that it is reversible in the future.</p> <p>All new materials should be date stamped.</p>

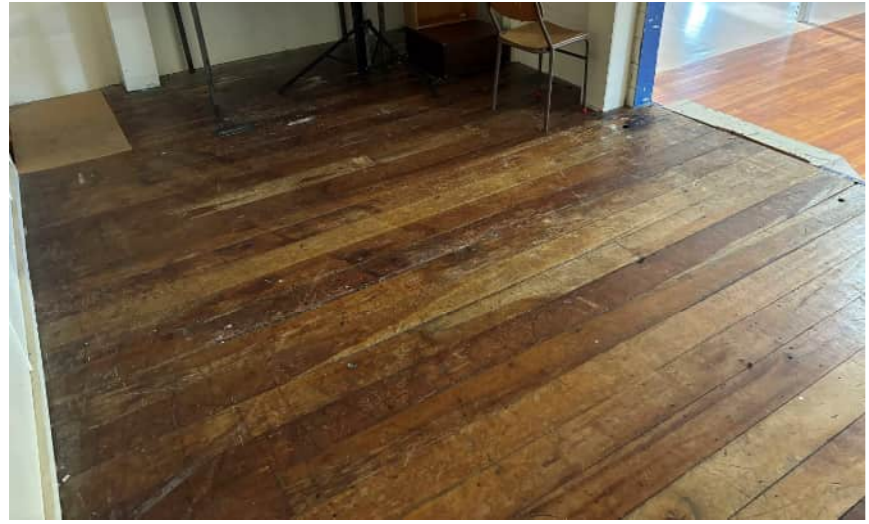
Timber T&G floorboards to raised stage (fixed)	Exceptional	The floorboards are an original feature of the building and are in worn but sound condition. No works affecting the floorboards are proposed.	Neutral

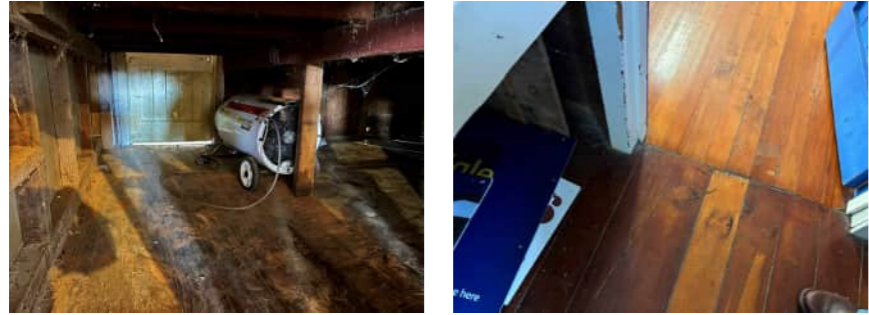
Timber T&G floorboards to sub-stage area	Exceptional	The floorboards are an original feature of the building and are in good condition. The drawings indicate that there will be new braced piles along gridline 6 below the stage. Floorboards may need to be lifted to get access for installing these new foundations.	Moderate Adverse	The condition of the existing fabric should be photographically recorded prior to, during, and at completion of the works. Floorboards should be carefully removed in full lengths only, and should be reinstated in their original locations, with all works carried out following a methodology that has been approved by a heritage specialist. If this recommendation is followed, and the methodology is carefully carried out by the contractor, the disturbed areas should not be visible, and the adverse effect would be reduced to negligible.

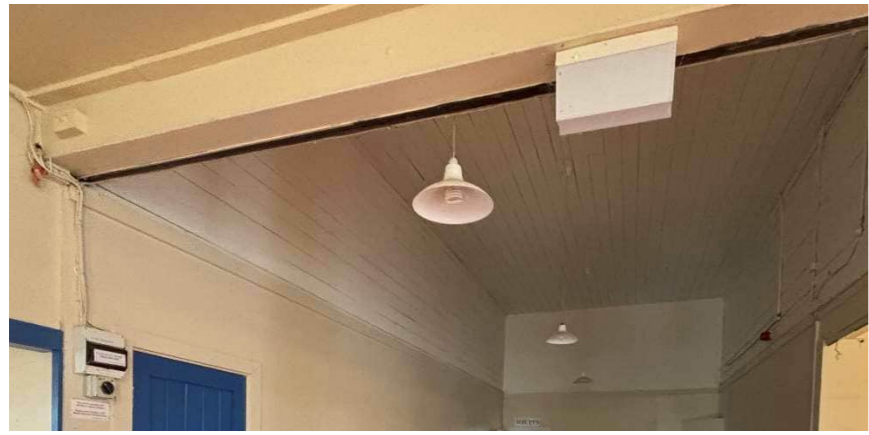
TG&V ceiling linings	Exceptional	The flat ceiling over the stage is lower than the vaulted ceiling over the main hall, but is also lined with timber TG&V which is original fabric. The ceiling incorporates an access hatch to the roof space. No work is proposed to the ceiling itself, but rectangular trims at the wall-to-ceiling junctions will need to be removed for wall lining works.	Neutral	
	Softboard ("Beautyboard") wall linings, battens and skirting boards to wall on gridline 7	Intrusive	The softboard wall linings have been applied over the original TG&V wall linings up to approximately two thirds of the wall height. It is assumed that this was done in the 1970s when the building additions were made. These are to be removed and disposed of.	Moderate Beneficial

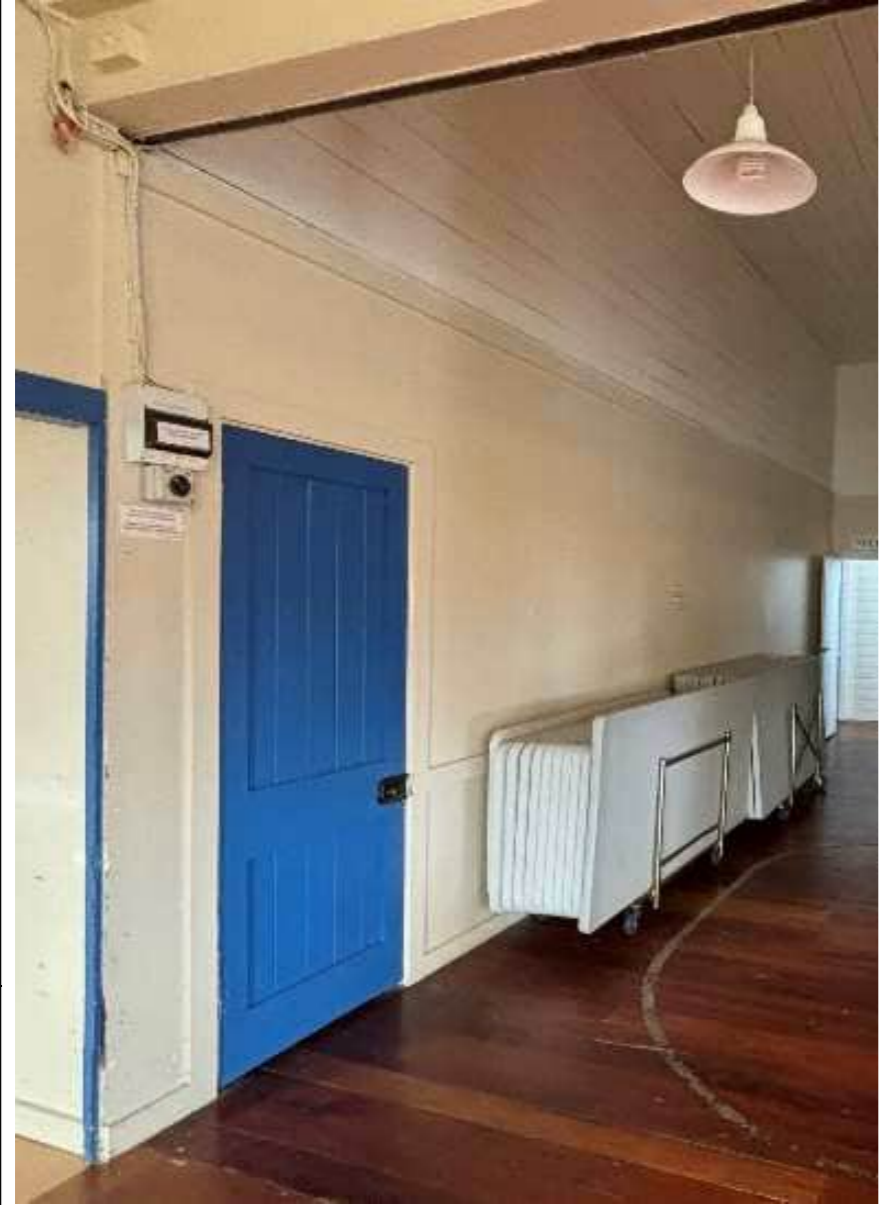
Timber TG&V linings to wall on gridline 7 (visible above softboard)	Exceptional	<p>The TG&V wall linings are original fabric.</p> <p>The proposed strengthening scheme requires a layer of GIB board to be added to one side of this wall, with GIB grabber high thread screw fixings in accordance with the GIB EzyBrace Systems specification. The documents do not specify which side of the wall the GIB is to be fixed to, but it is assumed that it would be applied to this side for reasons of access.</p> <p>Further, the drawings show that it is proposed to use GIB Fyreline (in place of Braceline) on this wall along the length of the stage as part of providing the fire rating for the under-stage area recommended in the Fire Report.</p> <p>Overlining will cause additional and unnecessary damage to the TG&V and continue the concealment of original fabric, which together have a minor adverse impact.</p> <p>There is no mention of a scotia or equivalent moulding to conceal the wall-to-ceiling junction.</p>	Minor Adverse	<p>Seajay Consulting should confirm whether it is <u>possible to achieve the required bracing using the same TG&V screw-fixing methodology as the wall on gridline A, noting that both sides of the wall are lined with TG&V that could be screw fixed.</u></p> <p>If this is possible, Seajay Consulting should confirm whether it is necessary, when considering what is 'as near as reasonably practicable', to fire rate the area below the stage, given that it is such a small part of the building and it is highly unlikely that a fire will ever occur in this space.</p> <p>Assuming that no additional linings are required, and the TG&V is in reasonable condition, it should be exposed. As for TG&V linings in the foyer, screw holes should be pre-bored to prevent splitting, and screws installed to allow flush finishing of holes. Any nails left embedded in the TG&V from the softboard linings should be removed. All holes should be filled and sanded, and the wall repainted. Once complete the work should not be visible, and the overall fabric loss is small.</p> <p>If this recommendation is followed, the adverse effect would be reduced to negligible.</p> <p>Regardless of the outcome of the above, the condition of the existing fabric should be photographically recorded prior to, during, and at completion of the works. New materials should be date stamped.</p>

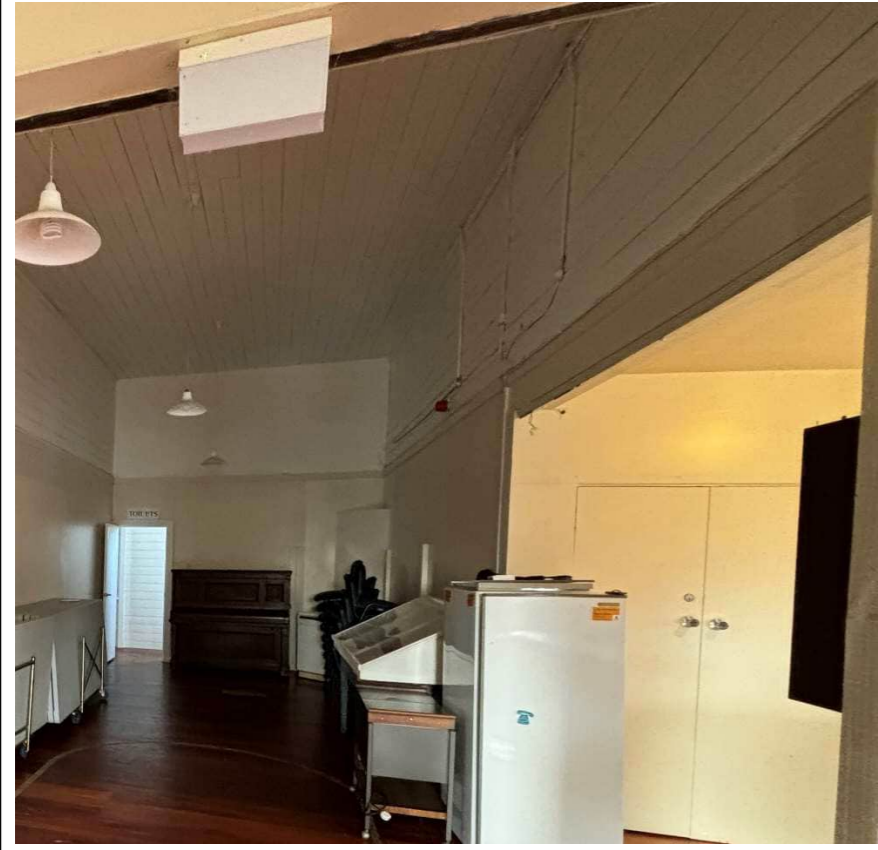
Timber TG&V linings to wall on gridline 8 (visible above softboard)	Exceptional	This wall was partially removed in the 1970s for the dining room and kitchen alterations, and replaced with a beam. The TG&V wall linings that remain on this wall, including the portion of the wall in what is now the corridor, are original fabric. The proposed strengthening scheme requires this wall (excluding the portion in the corridor) to be over-lined in GIB Braceline. This will cause additional and unnecessary damage to the TG&V and continue the concealment of original fabric, which together have a minor adverse impact. There is no mention of a scotia or equivalent moulding to conceal the wall-to-ceiling junction.	Minor Adverse	<p>Seajay Consulting should confirm whether it is possible to achieve the required bracing using the same TG&V screw-fixing methodology as the wall on gridline A.</p> <p>If this is possible, and the TG&V is in reasonable condition, it should be exposed. As for TG&V linings in the foyer, screw holes should be pre-bored to prevent splitting, and screws installed to allow flush finishing of holes. Any nails left embedded in the TG&V from the softboard linings should be removed. All holes should be filled and sanded, and the wall repainted. Once complete the work should not be visible, and the overall fabric loss is small. If this recommendation is followed, the adverse effect would be reduced to negligible.</p> <p>Regardless of the outcome of the above, the condition of the existing fabric should be photographically recorded prior to, during, and at completion of the works. New materials should be date stamped.</p>

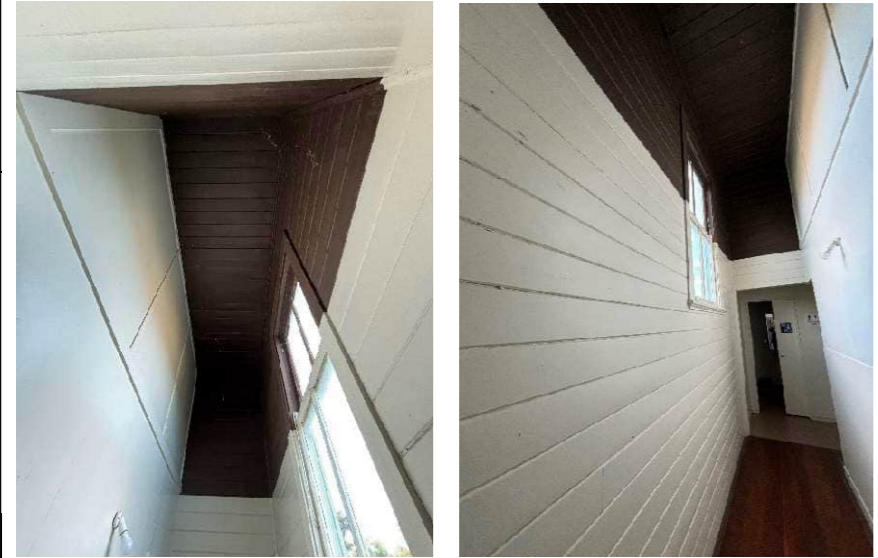
Dividing wall to corridor including door and all linings	Intrusive	This wall was added in the 1970s to create a corridor at one end of what had formerly been the open space of the anteroom that connected the toilet area to the corridor along the northeast side of the stage (with the stage wing folded up). It is an intrusive element as it carves up what was originally one space. No works are proposed to this wall or its parts.	Neutral	
	Timber TG&V wall linings to wall on gridline A	Exceptional	The TG&V wall linings are an original feature. The drawings indicate that the wall linings on gridline A are to be screwed to each framing member. Screwing the TG&V will create multiple holes in the fabric and there is a risk of associated damage if the boards are highly brittle. Screw holes are to be pre-bored to prevent splitting, and screws installed to allow flush finishing of holes. Holes are to be filled and sanded, and the wall repainted. Once complete the work should not be visible, and the overall fabric loss is small. Therefore, the adverse effect is negligible.	Negligible Adverse	<p>This rating assumes that note 55 on drawing S1 does not apply to the wall on gridline A.</p> <p>The wall should not be over-lined with GIB board or any other lining.</p> <p>Therefore, no architraves are required to be removed or replaced, and no packing of frames is required.</p> <p>Regardless of the outcome of the above, the condition of the existing fabric should be photographically recorded prior to, during, and at completion of the works. New materials should be date stamped.</p>

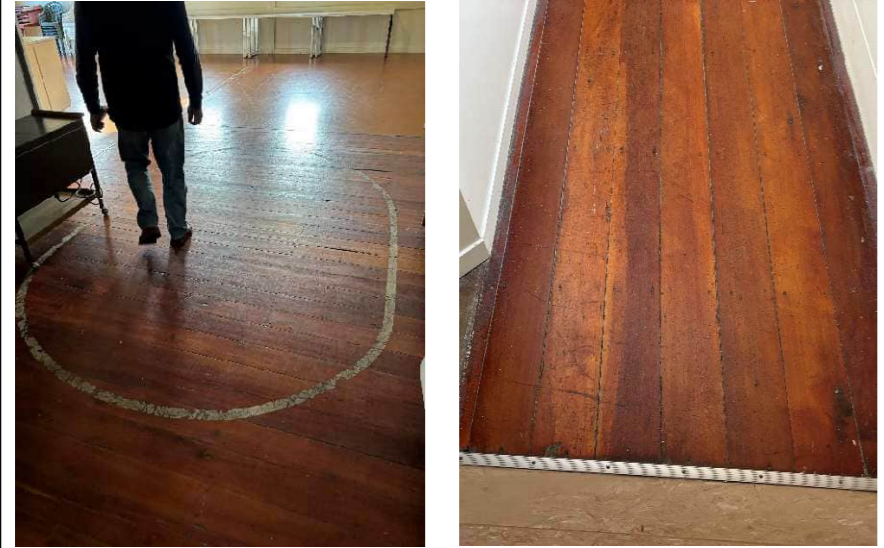
Timber T&G floorboards	Exceptional	The floorboards are an original feature of the building and are in good condition. The drawings indicate that there will be a new pad required at the intersection of gridlines C and 7. Floorboards may need to be lifted to get access for installing these new foundations.	Moderate Adverse	<p>The condition of the existing fabric should be photographically recorded prior to, during, and at completion of the works.</p> <p>If possible, access to the foundations on gridline C should be created through the floor of the annex and the work undertaken without touching timber floorboards.</p> <p>Floorboards should be carefully removed in full lengths only, and should be reinstated in their original locations, with all works carried out following a methodology that has been approved by a heritage specialist.</p> <p>If this recommendation is followed, and the methodology is carefully carried out by the contractor, the disturbed areas should not be visible, and the adverse effect would be reduced to negligible.</p>
